Service Bulletin

A Publication of Consolidated Metco, Inc.

Removing Frozen Hubs From The Spindle

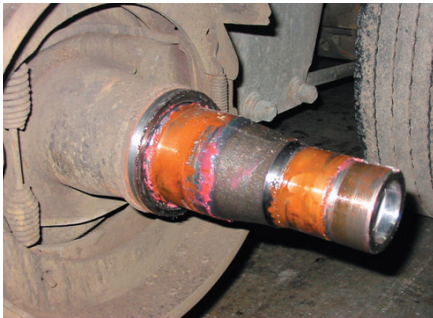
1. Minor wheel bearing failure
2. Fretting corrosion between the bearing cones and axle spindle (see Figure 1 and Figure 2)

During the disassembly of the hub, all hub components should be cleaned, dried, and inspected for fatigue or failure. If signs of deterioration are evident, it is required to replace these components as per the hub or bearing manufacturer's recommended practices. In cases where fretting corrosion is found on the spindle bearing journals, it should be removed with a fine abrasive, such as emery cloth, prior to reinstalling the hub assembly. Consolidated Metco recommends that a thin coating of a grade 2 grease, preferably moly based be applied to the spindle bearing journals prior to installing the hub to prevent fretting corrosion from reoccurring.

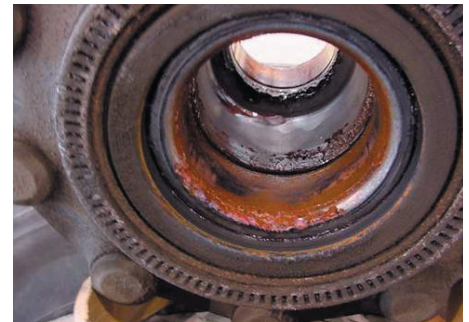
Figure 2

Fretting Corrosion is corrosion that can occur on the load bearing contact surface between mating material, leaving a reddish-brown stain on the spindle or bearing cone.
