Service Bulletin

A Publication of ConMet

Service Alert: Potential for Water Contamination in Hub Due to Flooding

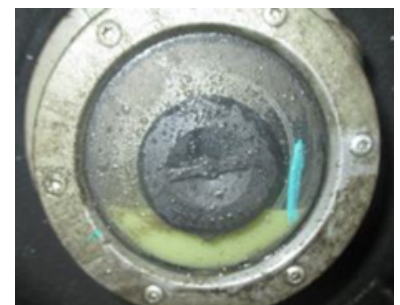
Oil lubricated hubs can be inspected through at the sight window in the hubcap. Oil, such as a 50 weight synthetic, with a small amount of water added will turn to a milky white color (Figure 1).

The complete axle should be inspected, including the differential, for water contamination and serviced per the OEM recommendation. The rear hub can be inspected by draining the oil from the fill plug. If discoloration as shown in figure 1 above is observed, the wheel end has experienced water contamination.

Figure 1: 50 weight synthetic oil contaminated with a small amount of water turns milky white.

A complete tear down of the wheel end should be performed and all components thoroughly cleaned.

Inspect bearing cups and cones for water corrosion, rusting, and unusual signs of wear. If unsure if bearings set can be resused, the safest option is to replace. Even a small amount of corrosion can lead to spalling and failure of the bearing.
